**Special Inspector General for
Afghanistan Reconstruction**

SIGAR Inspection – 13-1

KUNDUZ ANA GARRISON: ARMY CORPS OF ENGINEERS RELEASED DYNCORP OF ALL CONTRACTUAL OBLIGATIONS DESPITE POOR PERFORMANCE AND STRUCTURAL FAILURES

OCTOBER
2012

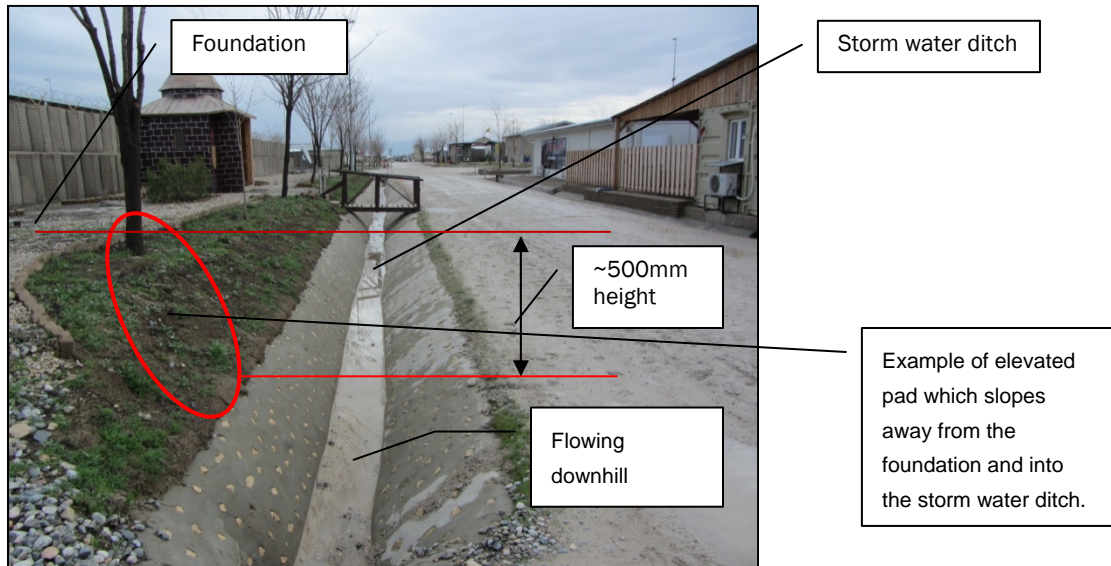
Figure 1 - Kunduz PRT March 2012 with Elevated Building Pad and Positive Drainage System

Figure 1 illustrates a typical drainage channel and elevated building pad at the Kunduz PRT.

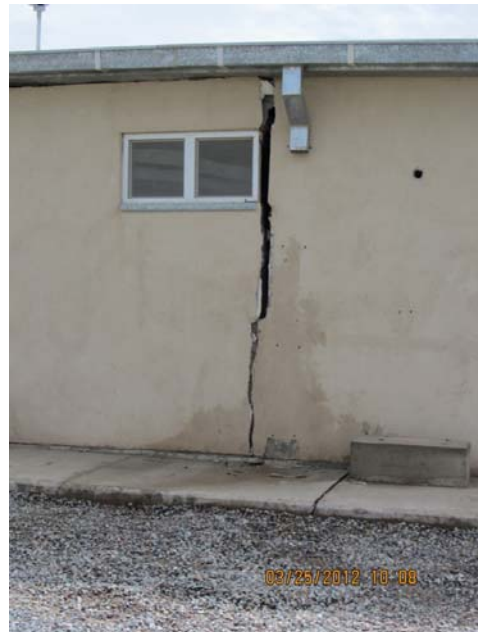
During our inspection on March 25, 2012, we observed that building 603 (latrine)²⁰ was unusable due to structural failure because of soil subsidence.²¹ We also noted that building 604 (barracks)²² adjacent to the latrine was beginning to settle and was at risk of failure. USACE-TAN officials attributed the structural failure to water infiltrating into the soil underneath the building. The location of these facilities is noted in figure 2. Figures 6 and 7 are examples of wall separation, both inside and outside building 603.

Figure 6 - Interior of Building 603

Figure 7 - Exterior of Building 603

²⁰ In its response to this report, USACE-TAN stated that a replacement latrine is included in a modification to contract W5J9JE-11-C-0076, Biltek, Garrison Expansion (phase III) project.

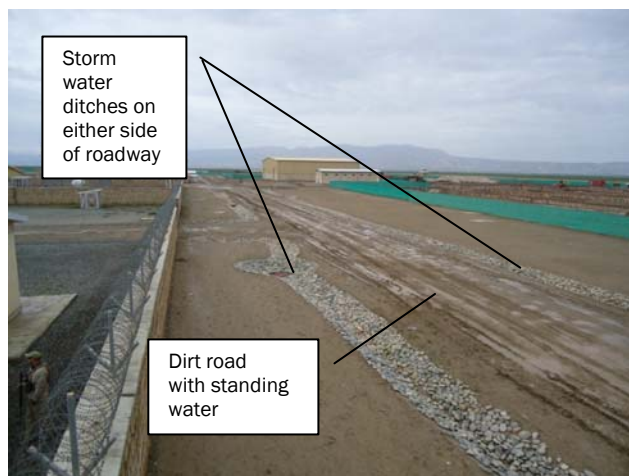
appropriate road grading, water accumulated on the road surfaces and drainage channel, indicating improper drainage. Figure 10 illustrates standing water on one of the road surfaces.

Figure 10 - Standing Water on Road Indicating that Water is Not Draining into Storm Water Ditches as Designed
